Distilled Water Tank Faucet

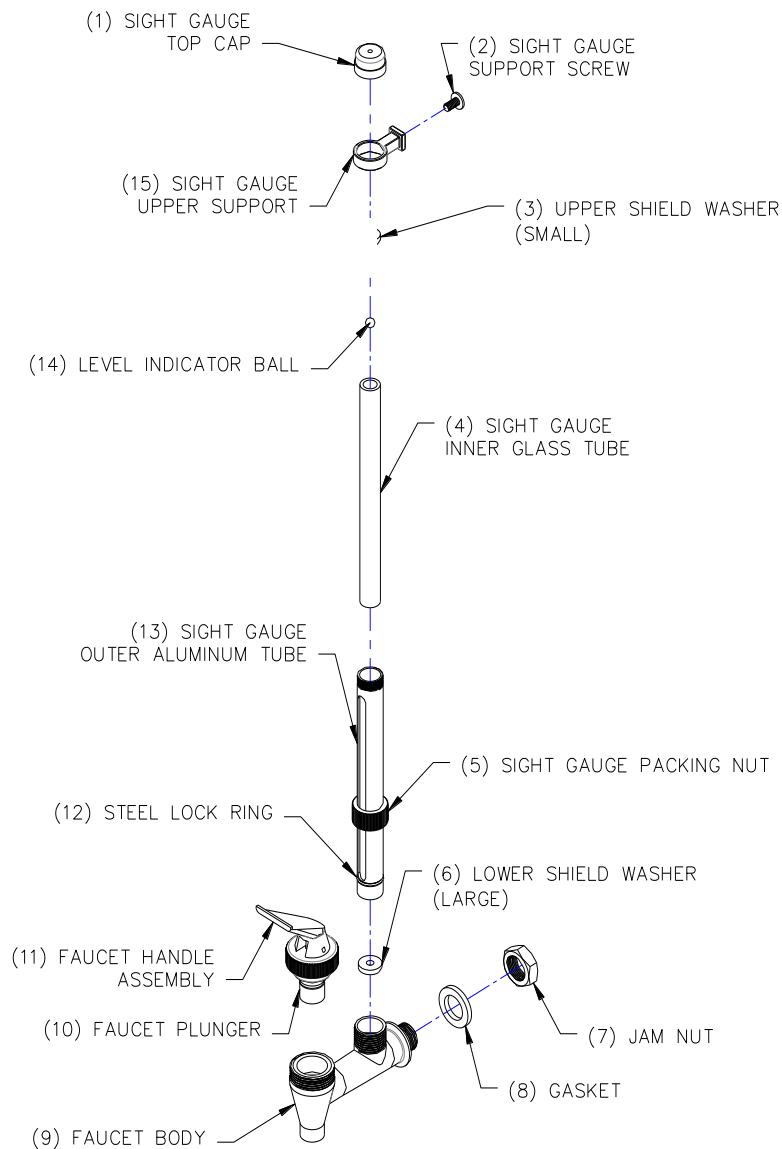
Part #500515; 500516; 500517 & 500518

If your faucet has a leak at the bottom of the sight gauge (13); Empty Storage Tank, remove the top cap (1) and unscrew the Packing Nut (5). Be Cautious to keep the washers (3 &6) and indicator ball (14). Check the glass tube (4) for any cracks or chips. When re-assembling, make sure the Steel Locking Ring (12) is in it's proper place within the grove at the bottom of the sight gauge (13). Place the larger washer (6) at the bottom of the faucet body (9), place the gauge (13) on top of the washer (6), and hand tighten the Packing Nut (5). There should be 2 rows of threads still visible under the packing nut. Place the glass tube (4) into the gauge, return the indicator ball (14) in the glass tube. Return the upper support (15) (*Not required on the 4" Sight Gauge*). Place the smaller washer (2) into the top cap (1) and screw onto the top of the sight gauge (13). Hand tighten till snug only.
